## GRE Fire Water Main Remediation and Anti-Corrosion Protection

**Job category:** Maintenance

Origin Energy engaged Basetec Services directly to Inspect, Engineer, Risk Assess, Remediate, Repair and Hydrotest an existing GRE fire water ring main at the Otway Gas plant in Victoria.

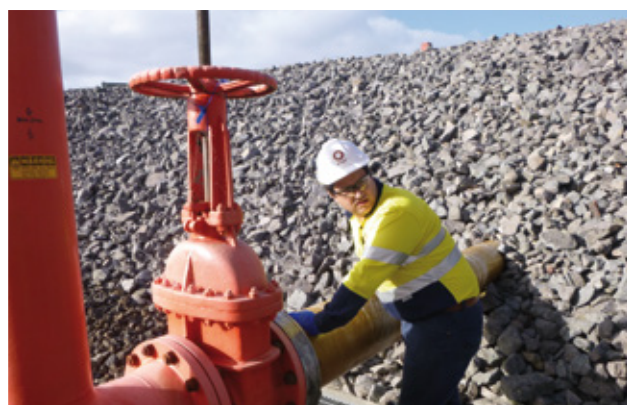
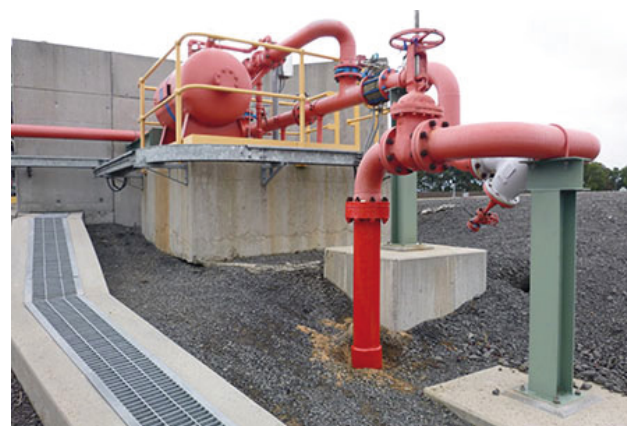
Basetec inspected and completed advanced pipeline repairs while the pipeline was still online and at which no time impacted on the plant. Basetec successfully hydrotested the pipeline also.

- NovaWrap Pipe Repair
- Novafast 2000 Resin
